Manhole Inspection Summary

Manhole # S37KK_003MH

Insp Date: **3/20/07 9:21 AM**

Location Address: **800 NORTH AVE**

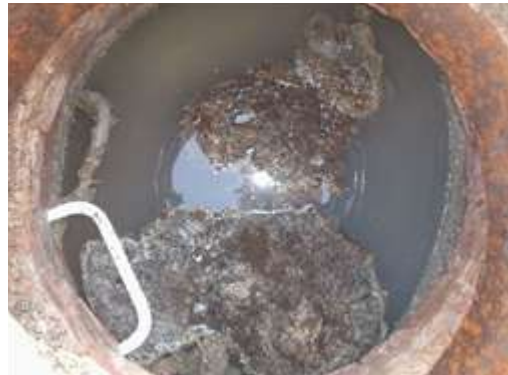
Top View

Surcharge ☒ **Evidence Of Surcharge** Depth: **4** (ft.) ☐ Active Surcharge Present

Active surcharge.

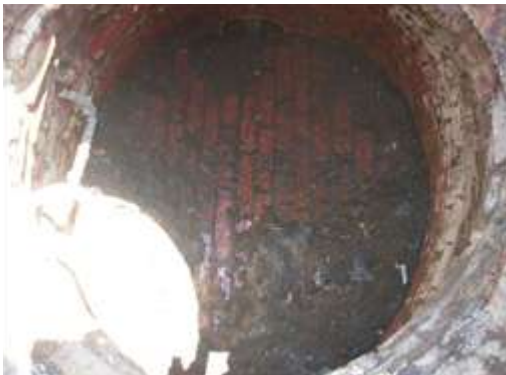
Top View

Channel Material: **Brick** ☐ Parged ☒ **Debris** (not Condition related)

Channel debris.

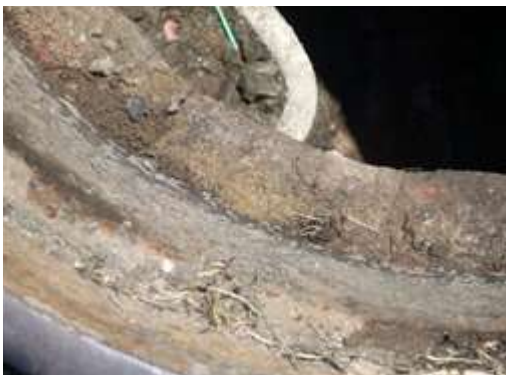
Defect

Frame Offset: **3** (in.) Condition: ☐ Sound ☐ Cracked ☒ **Leaks**

Frame leaks. Frame offset.

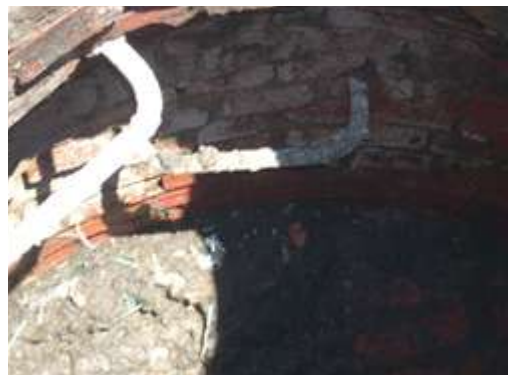
Defect

Infiltration: ☐ None ☒ **Joint** ☐ Cracks ☐ Mortar ☐ Roots ☒ **Wall**

Infiltration: ☐ None ☐ Joint ☐ Cracks ☐ Mortar ☐ Roots ☒ **Wall**

Corbel and Barrel infiltration.

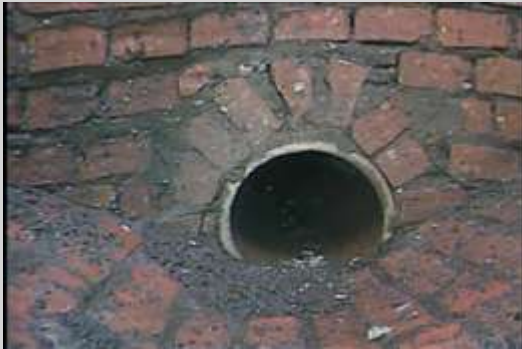
8 in. Circular Gravity Sewer
Pipe Out @ 12 O'Clock

Deposits: ☐ None ☒ **Mud** ☐ Sludge ☒ **Debris** ☐ Grease

Silt Depth: **0** (in.) Deposits Extent: **Light**
